MISCELLANEOUS PAPER GL-79-4

## EVALUATION OF THE EFFECTIVENESS OF MEMBRANES FOR PREVENTION OF CRACK REFLECTION IN THIN OVERLAYS

March 1979

Interim Report

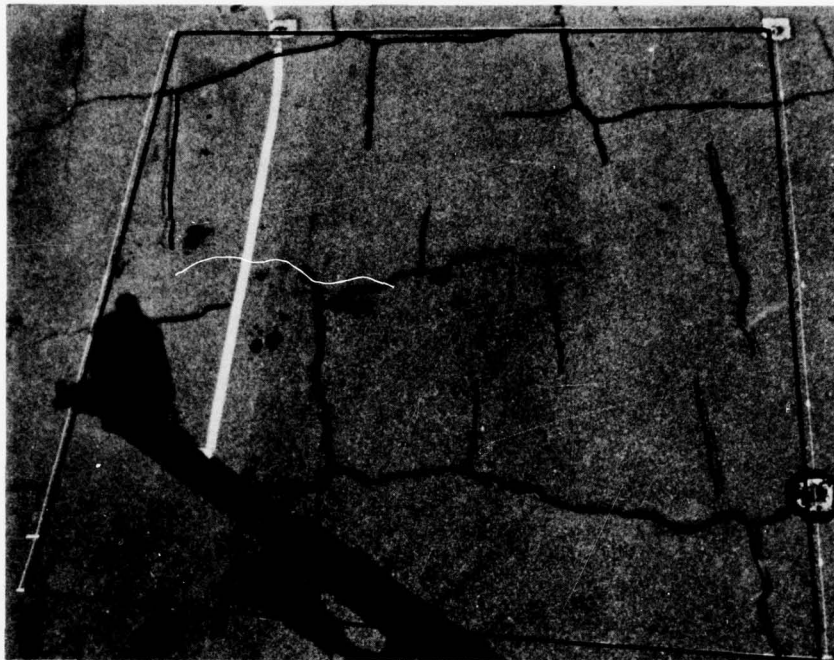
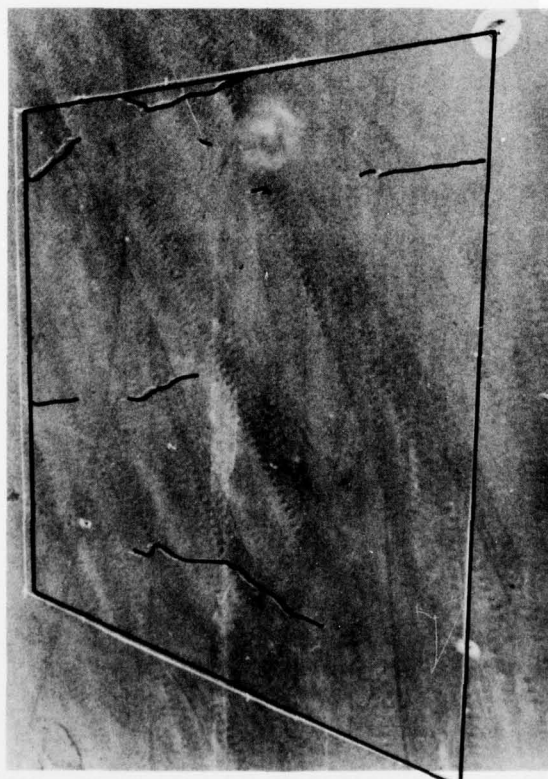
47. A visit to observe the performance of the various test sections was made on 11 May 1978. During the interval of the visit in November and May, a tar emulsion slurry seal (an item in the contract that had not been completed by November) had been placed over the apron surface. There were two selected 25- by 25-ft photographic areas in each test section (Figure 3). Photo 78 shows a general view of apron area prior to overlay. Photos 79-88 show the crack condition of the pavement prior to the overlay and 6 months after placement of the overlay. As noted in Photos 85 and 86, cracks in the selected photographic area in the Mirafi 140 section have reflected through the surface.

a. Condition of surface prior to overlay

b. Condition of surface 6 months after overlay

Photo 85. Fort Stewart--test square in south end  
of Mirafi 140 fabric section

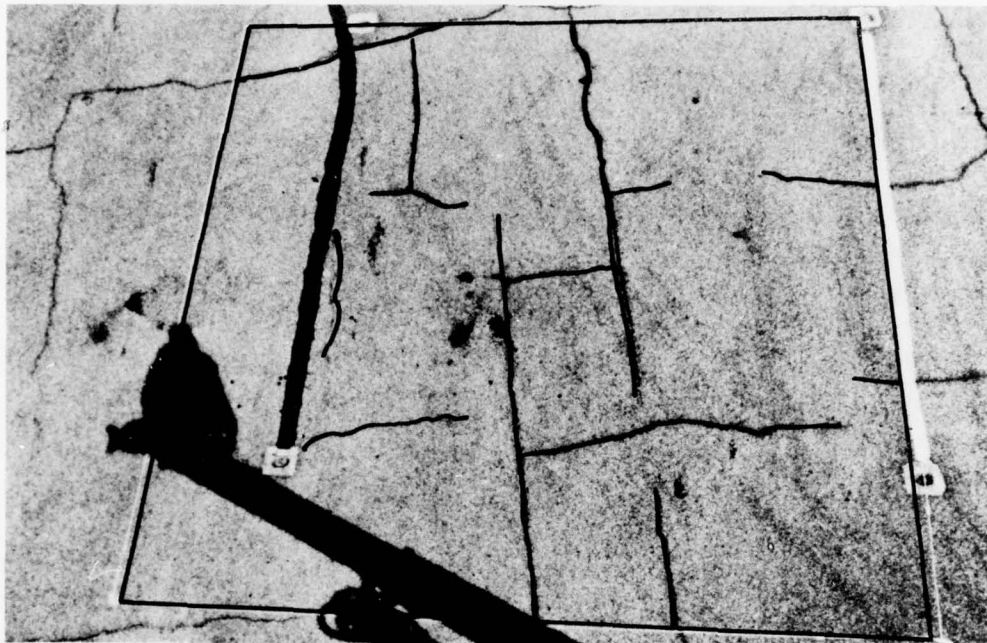
a. Condition of surface prior to overlay

b. Condition of surface 6 months after overlay

Photo 86. Fort Stewart--test square in north end  
of Mirafi 140 fabric section

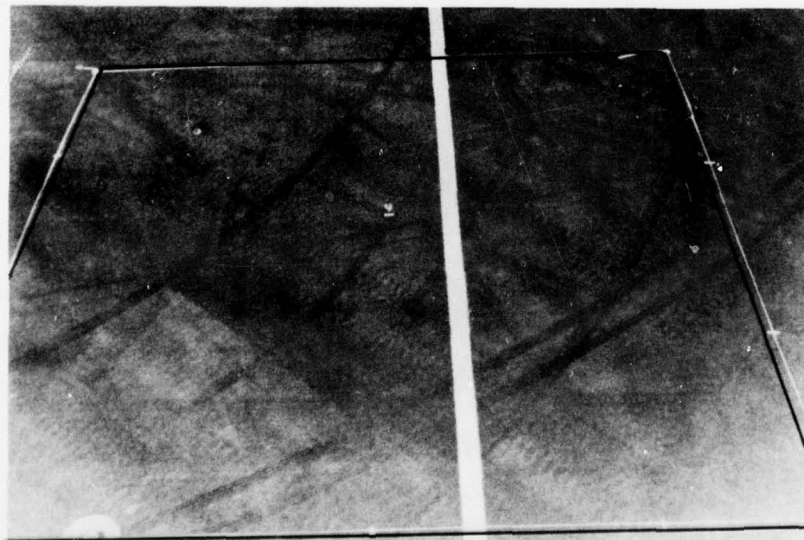
a. Condition of surface prior to overlay

b. Condition of surface 6 months after overlay

Photo 87. Fort Stewart--test square in south end  
of control section

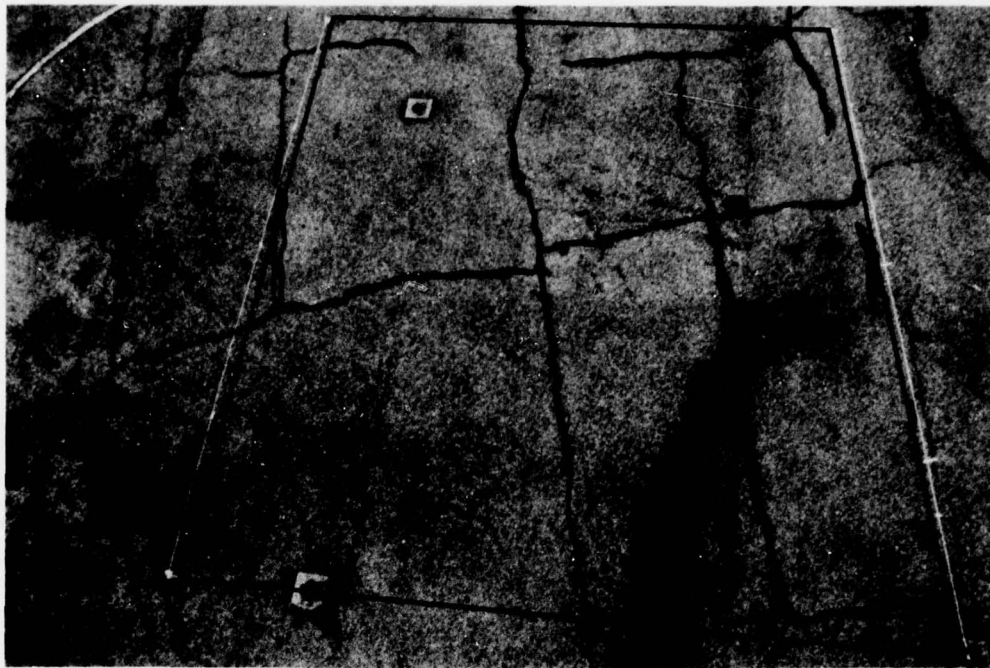
a. Condition of surface prior to overlay

b. Condition of surface 6 months after overlay

Photo 88. Fort Stewart--test section in north end  
of control section

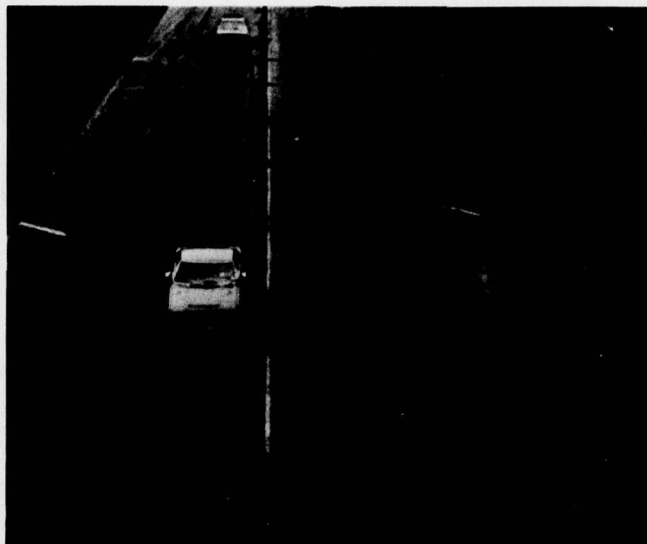
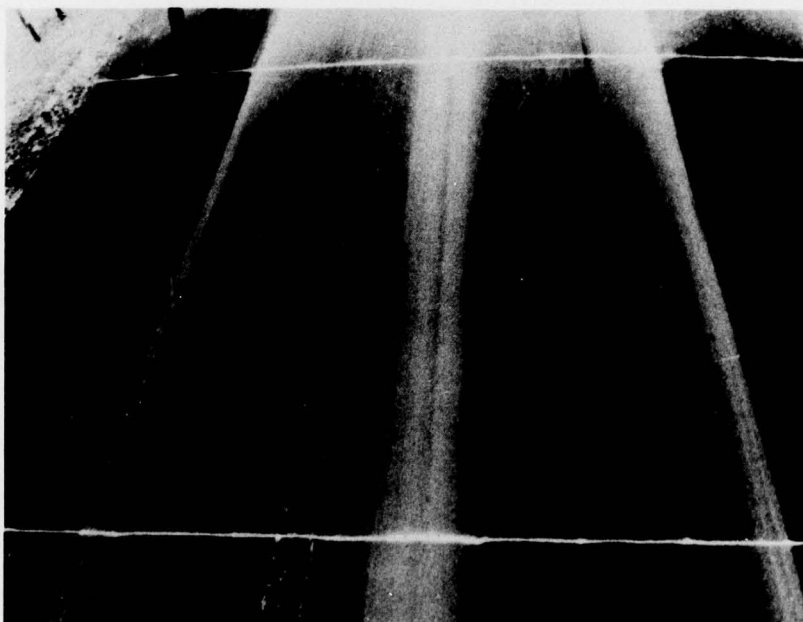
48. The survey to monitor the performance of the Petromat fabric on Louisiana Avenue at Fort Polk was made on 1 June 1978. Photos 89 and 90 indicate the crack pattern that existed in the selected photographic areas before placement of the overlay and 6 months after placement of the overlay. As noted in the photographs, two cracks in each 25- by 25-ft area existed from the underlying JC pavement, and these cracks have reflected through the fabric and overlay after the 6-month period. An inspection of the entire roadway indicated about 50 percent of the joint cracking has reflected through the overlay where the Petromat fabric was

a. Condition of surface prior to overlay

b. Condition of surface 6 months after overlay

Photo 89. Fort Polk--test section No. 1,  
Louisiana Avenue

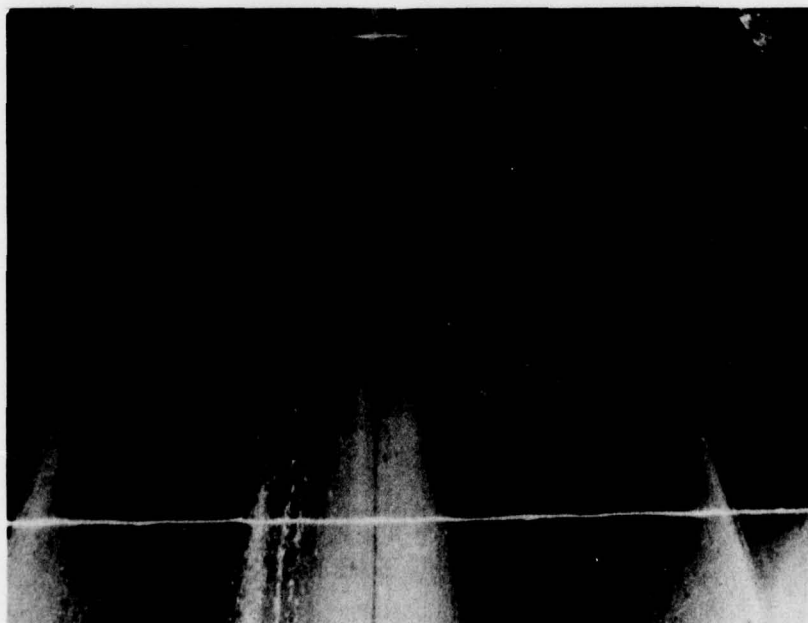
a. Condition of surface prior to overlay

b. Condition of surface 6 months after overlay

Photo 90. Fort Polk--test section No. 2,  
Louisiana Avenue

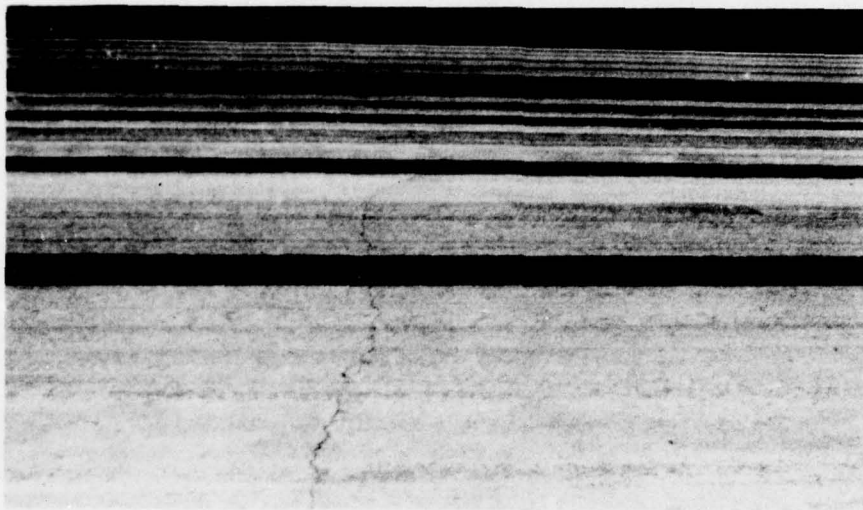
Photo 108. Fort Devens--reflected crack in NW-SE runway  
near NW end; interlayer of U. S. Rubber membrane

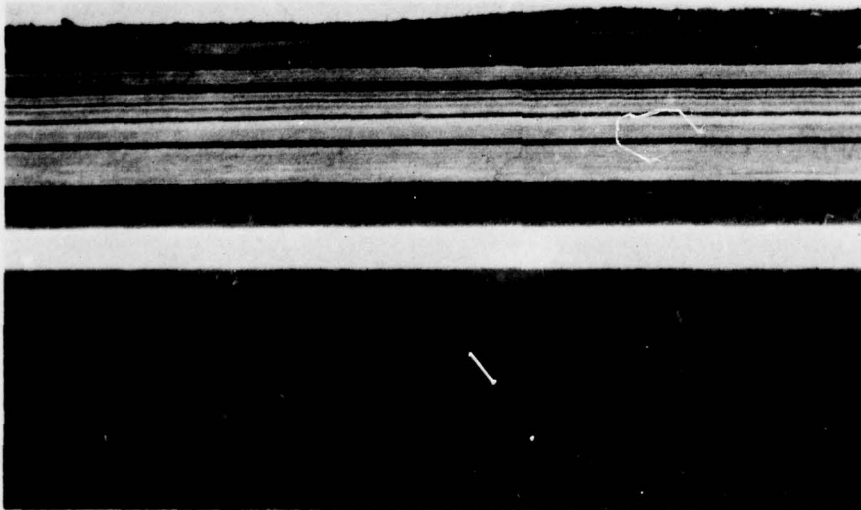
Photo 109. Fort Devens--one of five transverse cracks  
observed in control sections on NW-SE runway

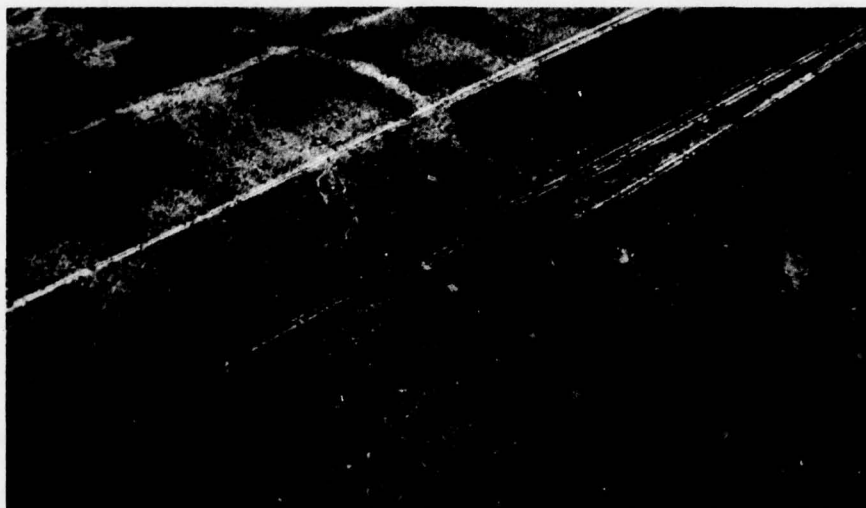
Photo 110. Fort Devens--gouged out area on N-S runway in  
Mirafi 140 test area from locked wheel turn of aircraft

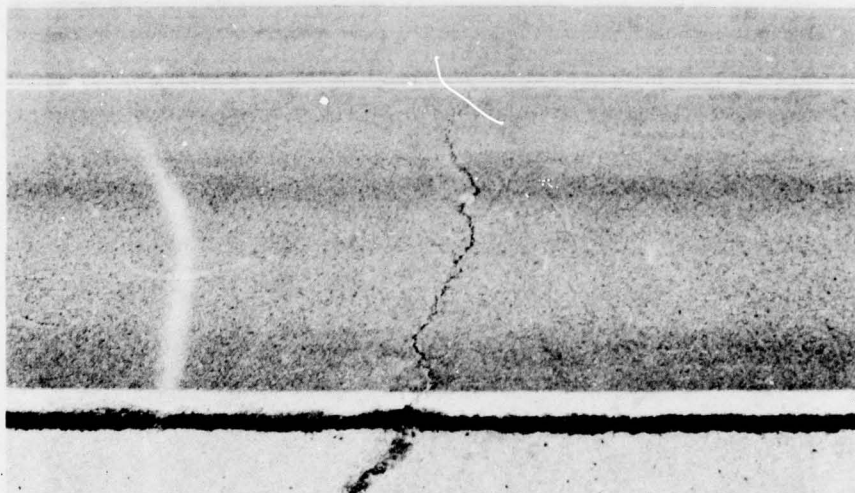
49. The survey to monitor the performance of the various test sections at Fort Devens was made on 7 June 1978. It was reported that the 1977-78 winter was one of the coldest this area has experienced in the past 50 years. Photos 91-107 indicate the crack pattern that existed in the selected photographic areas on the airfield prior to placement of overlay and 6 months after the placement of the overlay. No cracking was noted in the selected areas for the 6-month survey. A total of five transverse cracks in the entire length of the NW-SE runway were observed to have reflected for the area treated with the U. S. Rubber asphalt-rubber membrane (Photo 108). On the NW-SE runway (Photo 109), five transverse cracks were observed in the two 200-ft-long control sections. The small gouged area on the N-S runway (Photo 110), in the Mirafi 140 test area, apparently was caused by a locked wheel turn of an aircraft. The overlay slipped on the fabric and formed the resulting depression. Photos 111-115 indicate the cracking pattern for Barnum Road; and as noted, no cracks have reflected in the selected areas. Some cracking was found in the overlay surface of Barnum Road outside of the test areas (Photo 116).

Photo 116. Fort Devens--reflected crack  
in Barnum Road outside of test areas

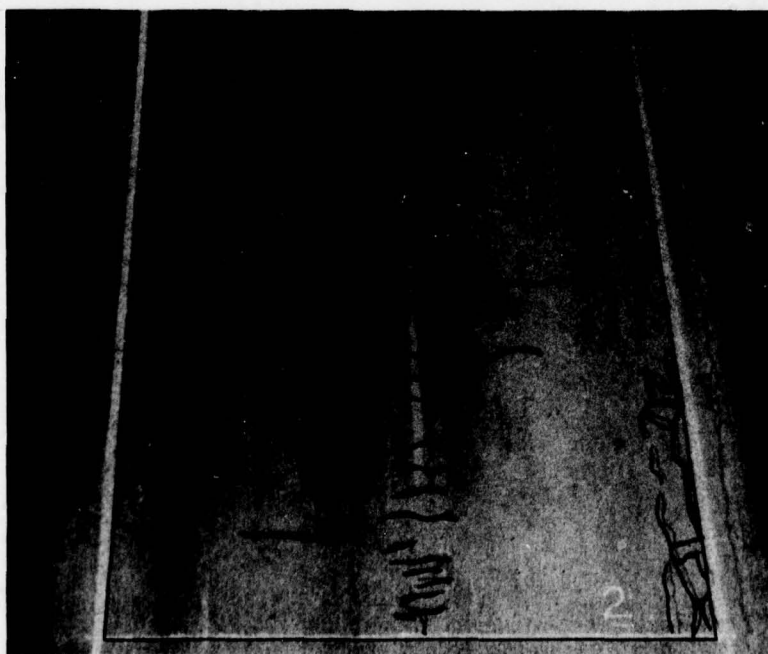
Photo 118. Fort Carson--condition of test area No. 2  
prior to overlay

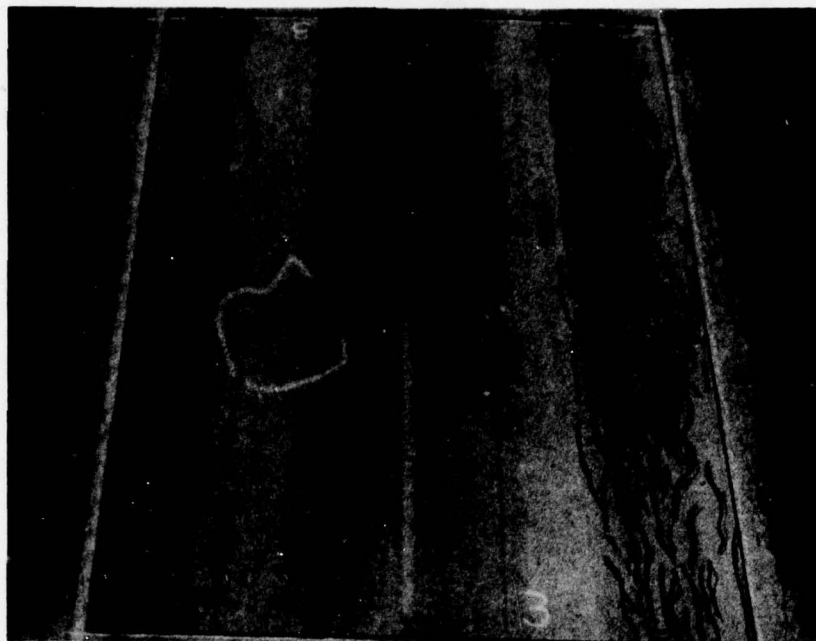
Photo 119. Fort Carson--condition of test area No. 3  
prior to overlay

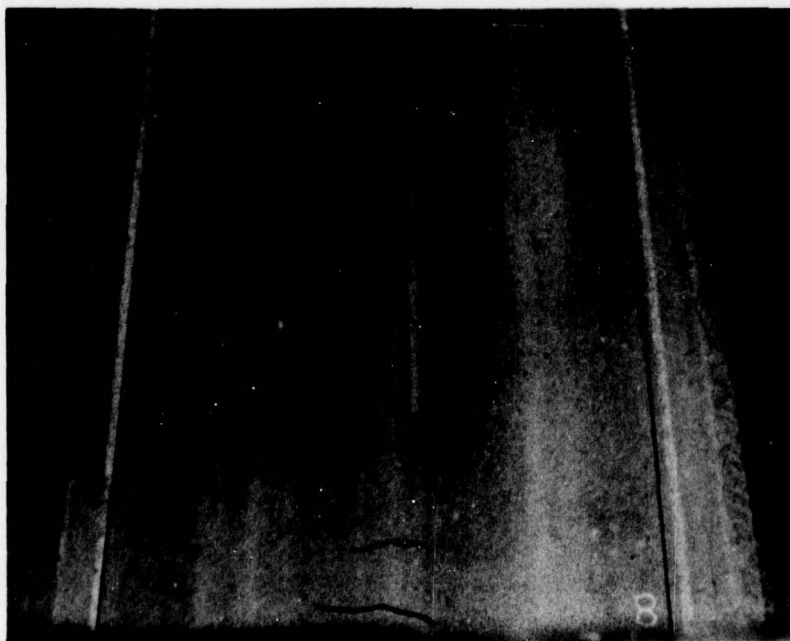
Photo 124. Fort Carson--condition of test area No. 8  
prior to overlay

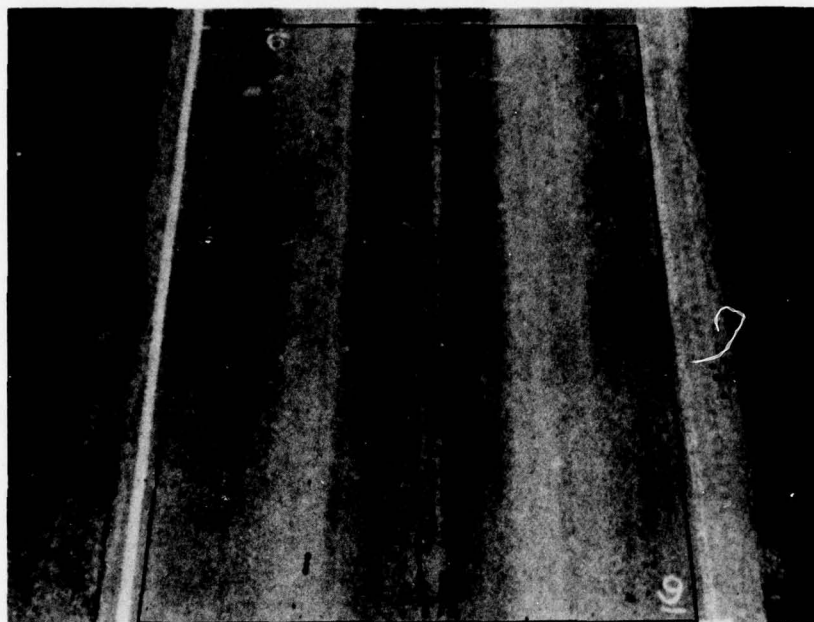
Photo 125. Fort Carson--condition of test area No. 9  
prior to overlay

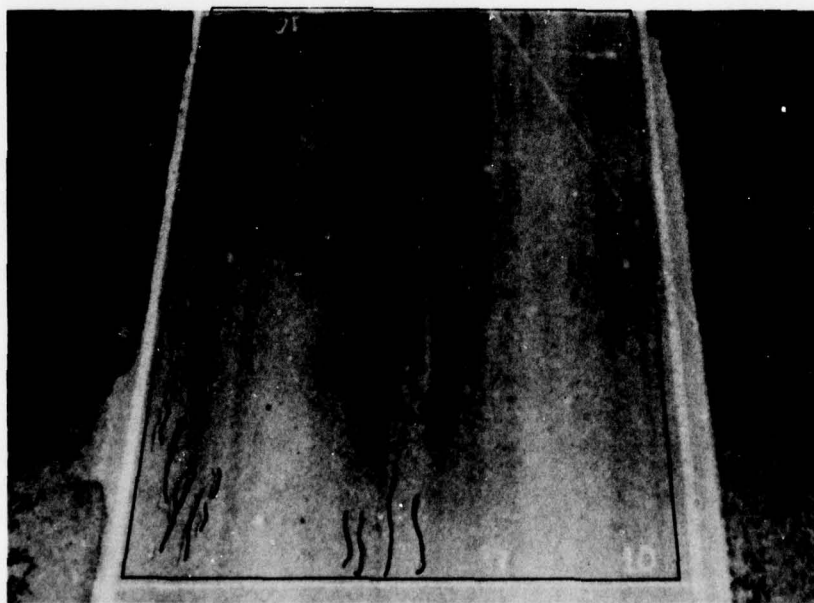
Photo 126. Fort Carson--condition of test area No. 10  
prior to overlay
